Lessons Learned From the Construction of Upgrades to the NASA Glenn Icing Research Tunnel and Re-Activation Testing

David W. Sheldon, Charles R. Andracchio, and Thomas M. Krivanek
Glenn Research Center, Cleveland, Ohio

Prepared for the
39th Aerospace Sciences Meeting and Exhibit
sponsored by the American Institute of Aeronautics and Astronautics
Reno, Nevada, January 8–11, 2001

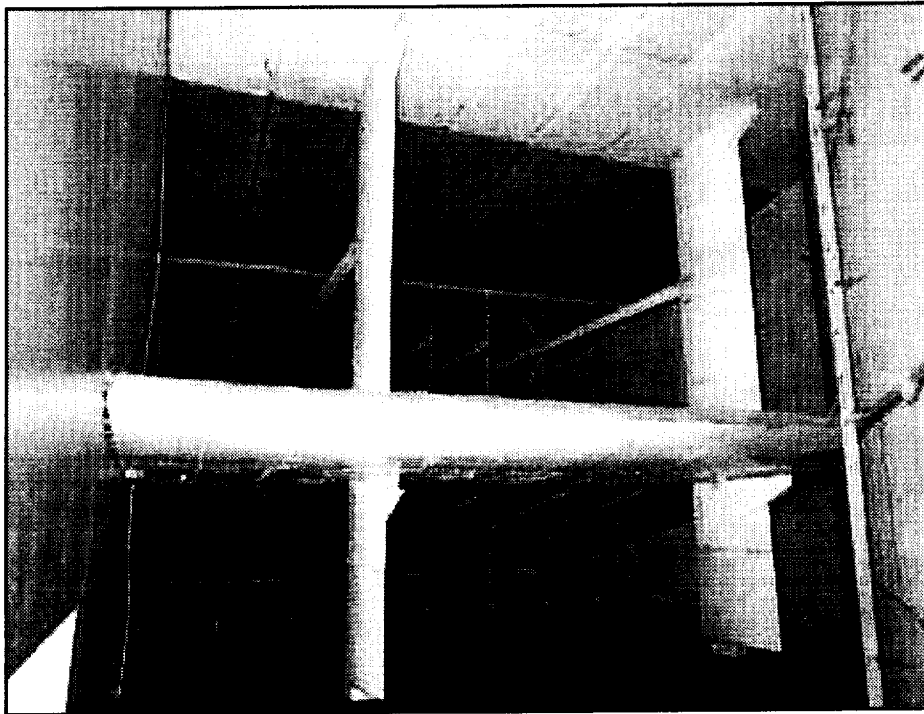
The Carrier Corporation installed the large copper tube-copper fin heat exchanger, with a nominal refrigeration capability of 2100 tons, in the IRT in 1943. After more than 50 years of service, the network of copper tubes was deteriorating to the point where the repair or closing-off of leaking tubes was responsible for about 100 hours of tunnel downtime each year. Leaks were occurring at silver-soldered joints at the end turns of the tubes, which were caused by the incompatibility of the R-134a coolant and silver solder.

(b) View upstream of the original IRT heat exchanger. The upper layer of fin-tube panels is out of view.
(C-99-1334)

Figure 2.—(Concluded) Original W-shaped heat exchanger in the IRT.

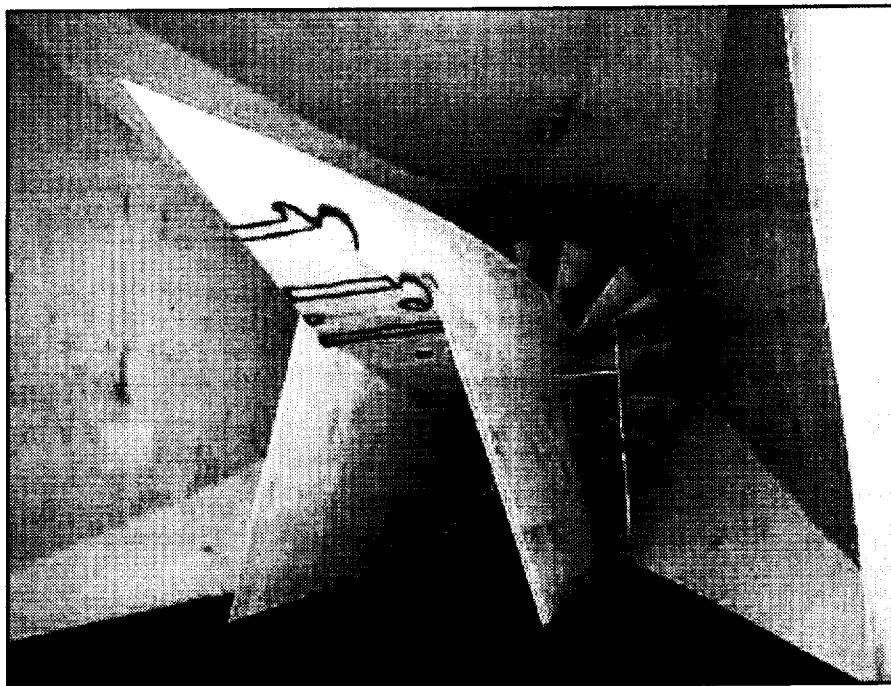
The airflow in the supply legs, from the vent tower section downstream of the fan through the refrigeration heat exchanger and into the stilling chamber has been shown to be unevenly distributed across duct flow areas.^{3,4} The two main causes of these flow distortions were the "W" shape of the heat exchanger and the presence of two large fairings around the legs of the fan motor support stand below the fan motor nacelle. These leg fairings are shown in **Figure 3**. The non-uniform distribution of airspeed across the heat exchanger produced non-uniform cooling rates, and this required a complicated balancing of the coolant flow through the various HX panels in order to achieve a uniform air temperature in the Test Section.

Figure 3.—View upstream of the IRT fan and motor housing. The two long fairings over the legs of the motor support platform are theorized to cause large variations in downstream air velocities.

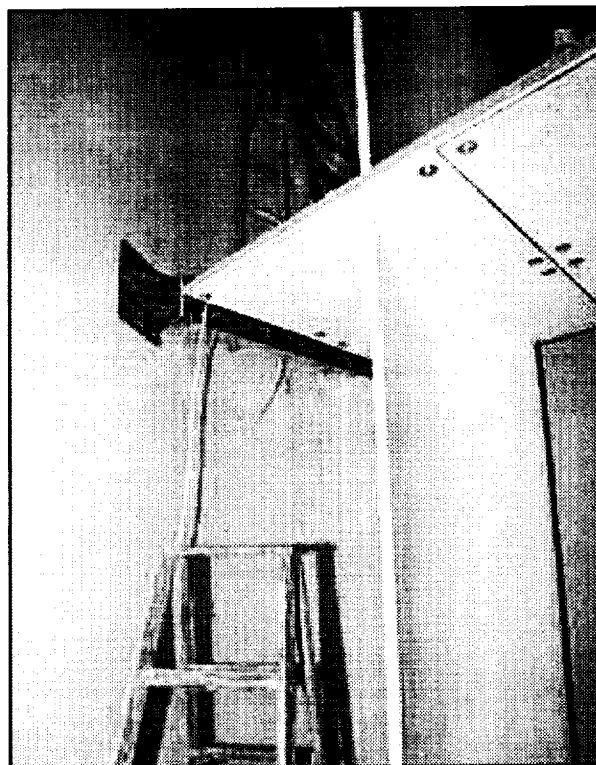
During flow quality testing in the stilling chamber downstream of the Corner D turning vanes, it was determined that the flow distortions of the bolted flanges and the tie plates had been underestimated. The wakes of these extraneous structures cause small local decreases in the downstream flow, and the extra pressure drops cause a small decrease in the maximum test airspeed in the tunnel. Leading- and trailing-edge fairings have now been added to the tie plates in Corner D. Improvements in flow quality are expected, but these have not yet been verified by test.

Figure 11.—View in Corner C of the trailing edge of vane C-1, showing the outer end of a tie plate sandwiched between bolted flanges. The reinforced end of the tie plate bears against brackets on the outer wall of the tunnel. (C-99-2432)

Recommendation: During the design phase, exercise more care in predicting the aerodynamic effects of alterations to an airfoil design, even when the alterations appear to be minor. Do not permit deviations from a clean aerodynamic profile unless absolutely necessary. For example, a smooth socket joint between segments of the turning vanes should have been considered before a flanged and bolted joint.

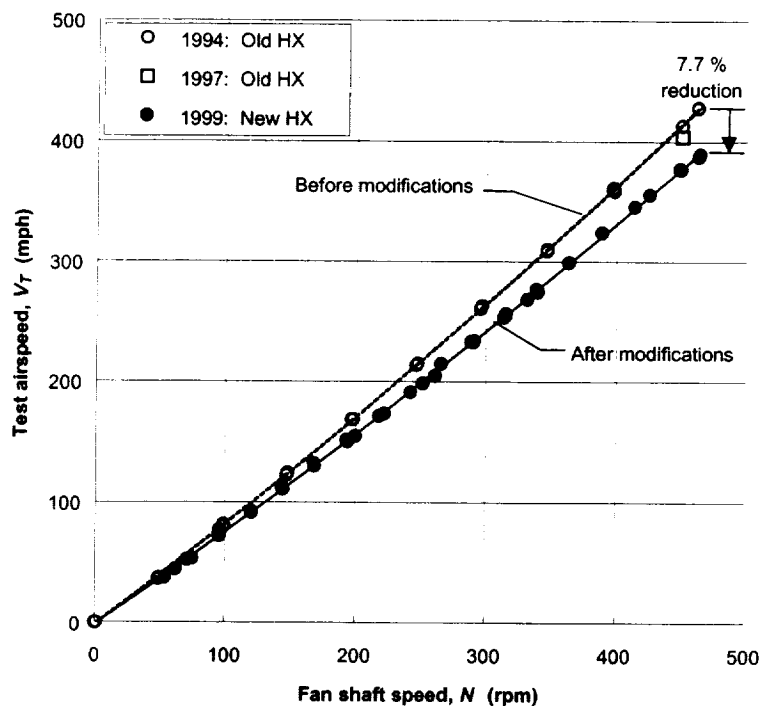
conditions. It can be seen from this chart that the maximum airspeed attainable in the IRT has decreased from its historic high of 420 mph (188 meter/s) measured during the 1994 qualification of new fan blades to approximately 390 mph (174 meter/s) today. This decrease is attributed to an approximately 50 percent increase in the drag losses across the flat HX compared with the original W-shaped HX, and to more drag loss than expected at the OGV's.

Figure 17.—Comparison of test airspeeds achievable in the IRT before and after tunnel modifications. Maximum airspeed was reduced approximately 8 percent.

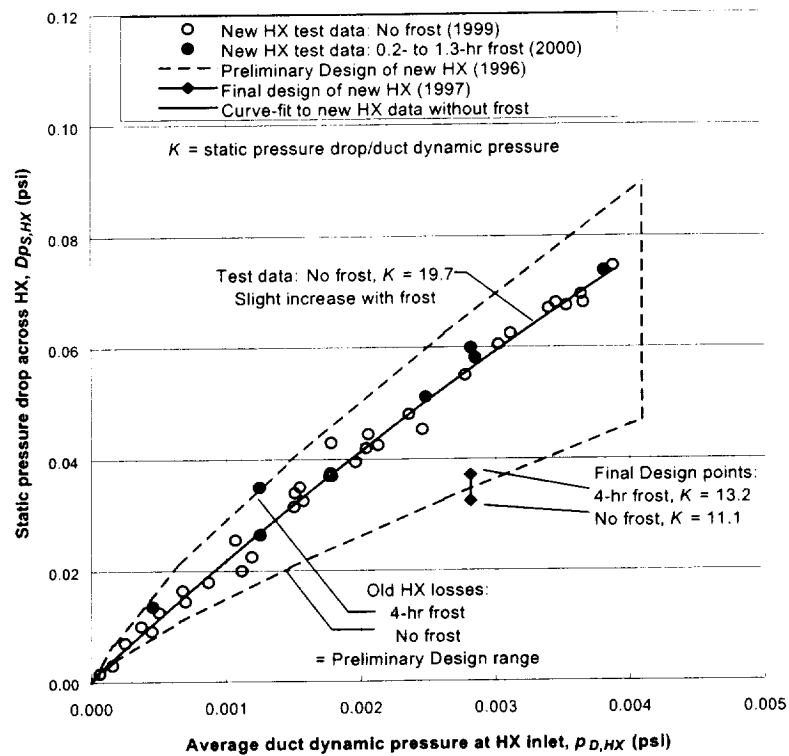
In **Figure 18**, pressure drops measured across the new HX are compared with design pressure drops. The range labeled "preliminary design" is a direct application of pressure drops measured across the original W-shaped heat exchanger, where heavy frost doubled the pressure drop.¹⁶ In the final design of the replacement HX, however, frost was expected to cause only a small increase in the pressure drop. The two final design points at the bottom of the range show this, which represent operation at a test airspeed of 300 mph (134 meter/s). Pressure losses across the new HX with or without frost were expected to be about the same as those with the original HX in a dry condition. Examination of the actual pressure drops measured across the new HX with and without frost shows that the minor effect of frost was correctly predicted. While the pressure losses without frost at the design point are about 70 percent higher than predicted, losses for the frosted condition are still lower than those for the original HX. Therefore, these additional drag losses at the HX are not expected to significantly affect tunnel operations during icing tests at moderate airspeeds and with test section blockage.

10. When static pressures were measured upstream and downstream of the new HX, it was determined that the pressure drop had been underestimated by about 70 percent during the final design phase. It is clear from this large error in predicting pressure losses that the procedures used for calculating the aerodynamic drag of this type of HX are not acceptable. However, the minor effect of frost on pressure loss was predicted correctly.

Figure 18.—Comparison of measured and design pressure drops across the replacement heat exchanger. Measured pressure drop is approximately 70 percent higher than the final design.

Recommendation: Use the measured loss coefficients from these IRT tests to calibrate improved methods for predicting the aerodynamic drag losses in HXs of this general configuration.

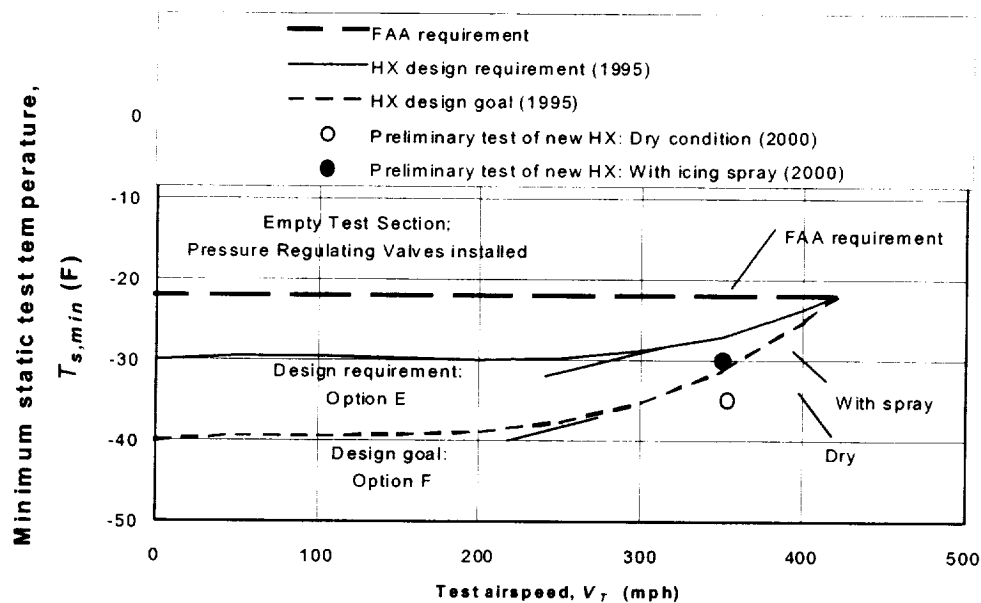
Figure 20.—Preliminary lowest-temperature data obtained with the pressure regulating valves in place and fully open.

Recommendation: Remove the 24 PRVs and replace them with no-loss spool pieces, eliminating the 2.5 psi (17 kPa) pressure drop through each.
